**ALABAMA HAZARDOUS WASTES MANAGEMENT AND MINIMIZATION ACT
(AHWMMA)**

Compliance Evaluation Inspection (CEI) Report

Charlie Mathews dba Eagle Battery, Inc. (Eagle Battery)
4015 Mobile Highway
Montgomery, Montgomery County, Alabama 36108

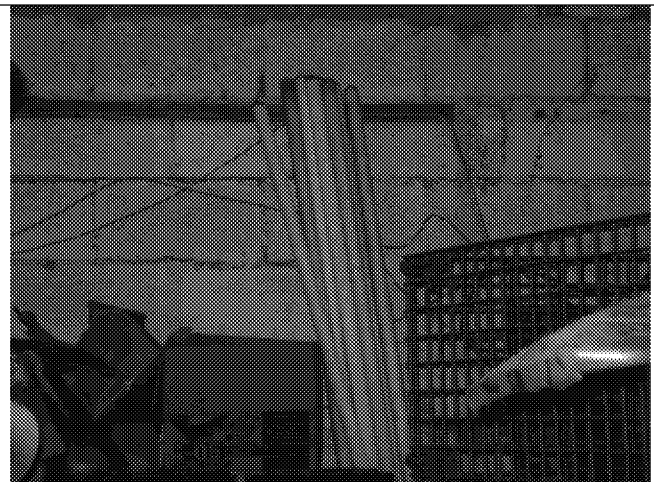
In the parts storage area, we saw seven six-foot long fluorescent lamps standing against one wall; four showed darkened ends that indicated they were burned out. Mr. Mathews said he thought all of them were spent, but he was not sure how long they had been there or what he should do with them. The lamps were surrounded by miscellaneous discarded materials, so we could not access them to ensure they were still intact. Batteries, acid, and other parts are stored on shelves and pallets along an adjacent wall. We saw four 25-gallon plastic drums of battery acid, including two that had been secured to a wooden pallet using plastic shrink wrap. These containers were identical to the one we saw at Sungwoo Auto. There were three pallets of used batteries in this area:

3 Spent fluorescent lamps

- Eagle Battery has not made a hazardous waste determination on the spent fluorescent lamps stored in the shop.
- Eagle Battery did not place in containers and mark as hazardous waste lead/acid batteries that showed signs of leaking acid, corrosion, or other damage.
- Eagle Battery did not keep closed all containers holding used oil.
- The used oil tank is rusted and the used oil markings are peeling off the tank.
- Eagle Battery could not provide documentation that used oil was collected by a transporter with a valid Alabama Hazardous Waste or Used Oil Transport Permit and an EPA identification number.

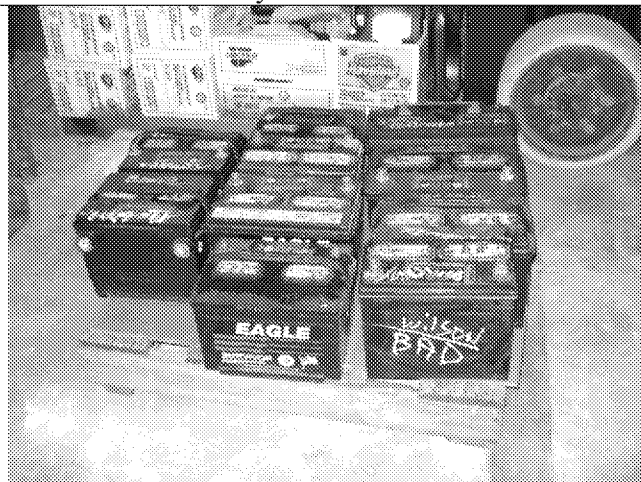
- One pallet held eighteen batteries that appeared to be in good condition and usable.
- One held ten batteries that appeared to be intact but were marked as being damaged or under warranty.
- The third pallet held nine batteries. Of these, two had open cells and four others showed evidence of leaks and/or corrosion.

7 Intact but damaged batteries

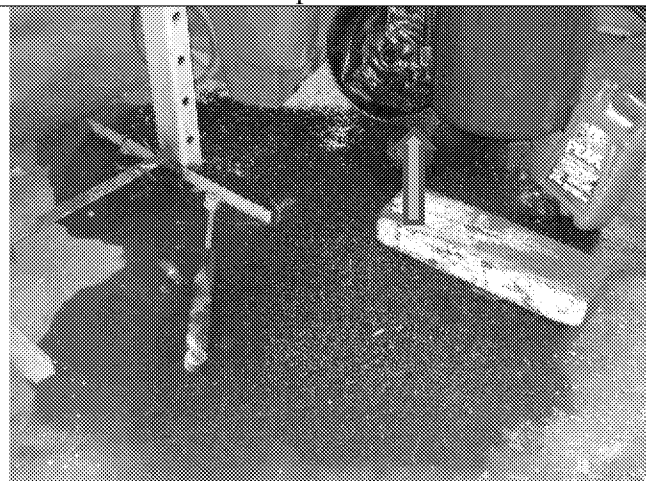
In the work bays, we saw spilled oil on the floor in one work area; it appeared to come from a used oil catch container that was lying on its side at one edge of the spill. The catch container still held residual oil. Adjacent to oil-stained area, there was a solid waste trash can that held several empty 1-quart oil bottles. Another catch container was sitting on the floor against the rear wall of the shop; it held what appeared to be a mixture of oil and water but showed no evidence of a release. According to Mr. Mathews, used oil is captured in catch containers then pumped into a used oil tank outside the building. Spent oil filters are drained and crushed, then disposed in the solid waste trash along with the empty oil containers. He said the business generates about twelve gallons of use oil per month. See Photograph #8 through 10.

8 Oil spill – note catch container on its side

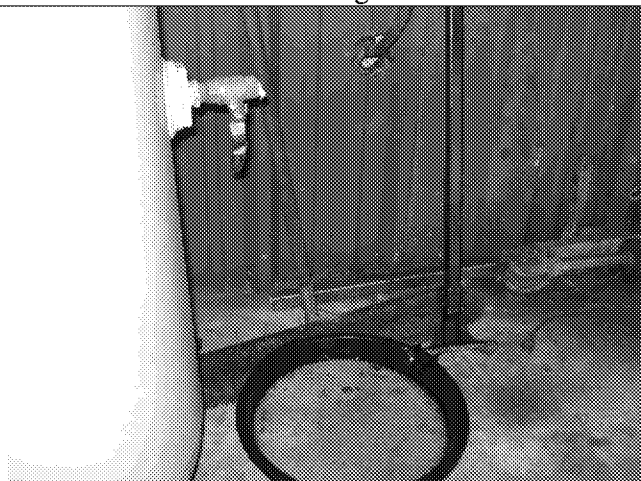
9 Catch pan holding a mix of oil and water

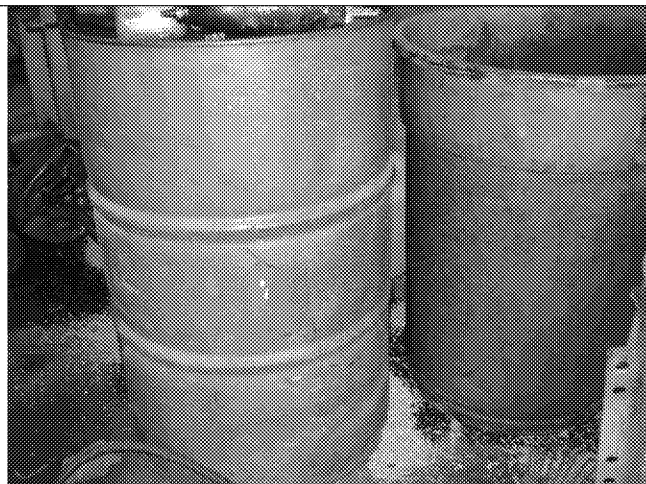
10 Spilled oil around trash can

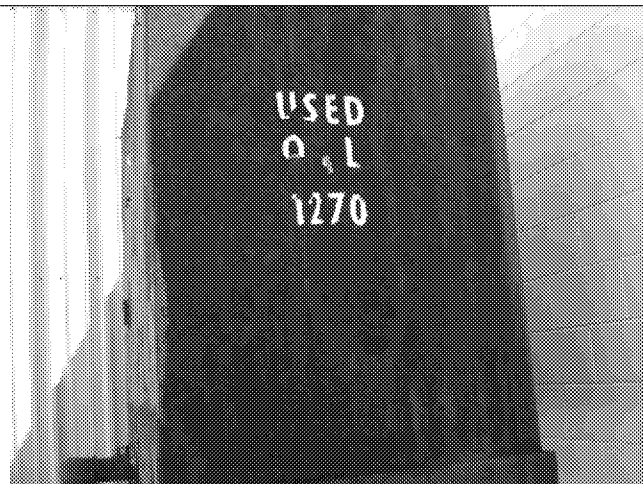
Along the north side of the building there is a 250-gallon metal tank marked with the words "Used Oil". The tank was intact, with no evidence of releases or leaks, but was very rusty. The lettering was beginning to peel off the side of the tank. See Photograph #11.

11 Used oil tank – marked but rusting
